# Wake County EMS Station 2

*Raleigh, NC*

**Wake County EMS Station 2**  
**Raleigh, NC**  
Drawing Title: COVER SHEET

## Metal Roof System

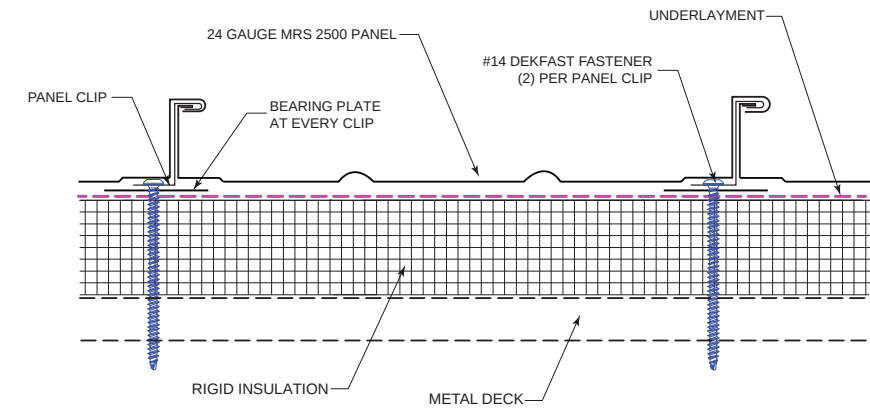
SYSTEM: MRS 2500 PANEL  
MATERIAL: 24 GA. GALVALUME  
COLOR: STANDARD

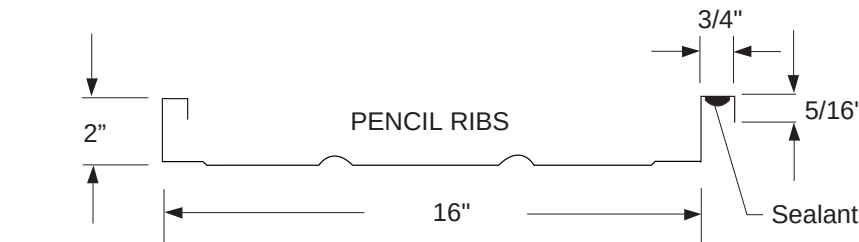
## Roof Panel Profile

SYSTEM: MRS 2500 PANEL  
MATERIAL: 24 GA. GALVALUME  
COLOR: STANDARD

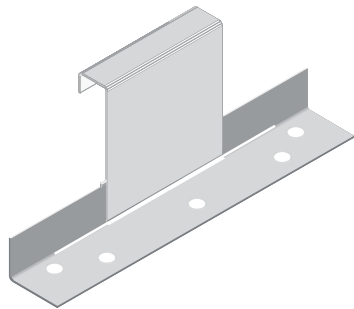
### 2" Floating Panel Clip

Base fabricated from 18 ga Galvanized Steel.  
Upper tab fabricated from 22 ga Galvanized Steel.

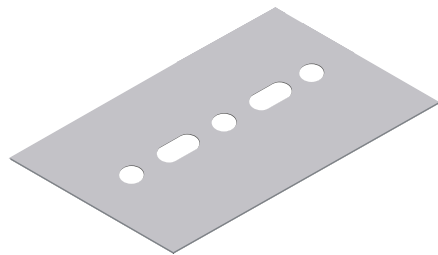
### Bearing Plate

20 GA G90 Galvanized. 3 in. wide by 6 in. long. Used under Panel Clips (Item 2) over purlins and rigid insulation. Three 1/4 in. dia guide holes located in base.

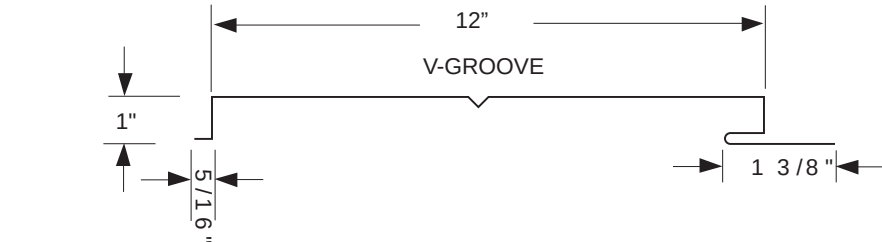
## Soffit Panel Profile

SYSTEM: MRS FLUSH SEAM PANEL  
MATERIAL: 24 GA. GALVALUME  
COLOR: STANDARD

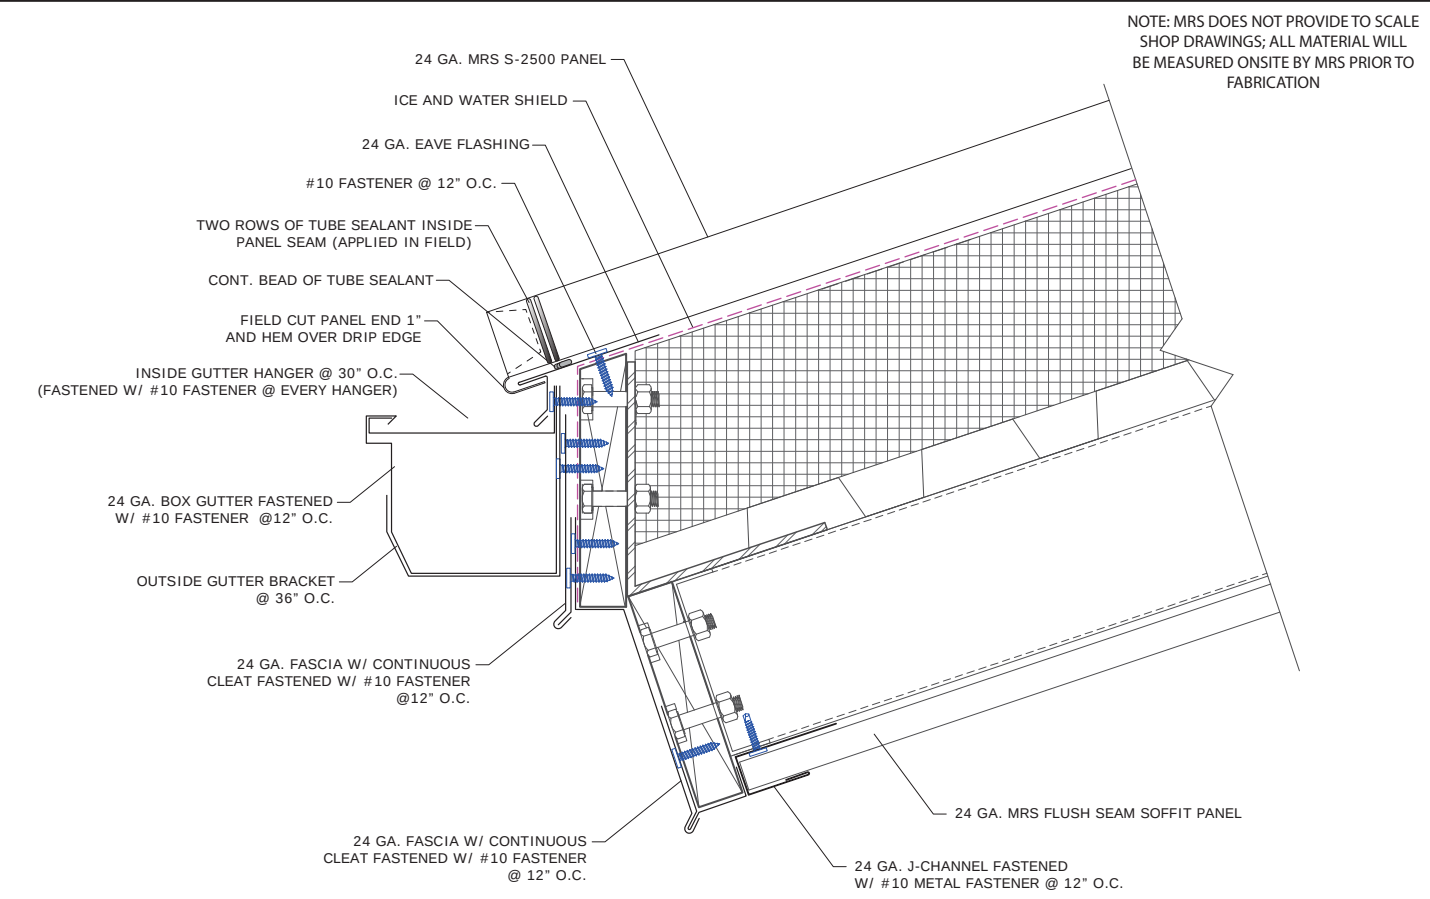
**1** Eave w/ Gutter

NOTE: MRS DETAILS ARE SHOWING THE PANELS BEING PINNED AT THE HIGH SIDE (RIDGE) AND FLOATING ON THE LOW SIDE (EAVE, VALLEY) THIS ALLOWS FOR THE PANELS TO FLOAT AT THE EAVE AND VALLEY

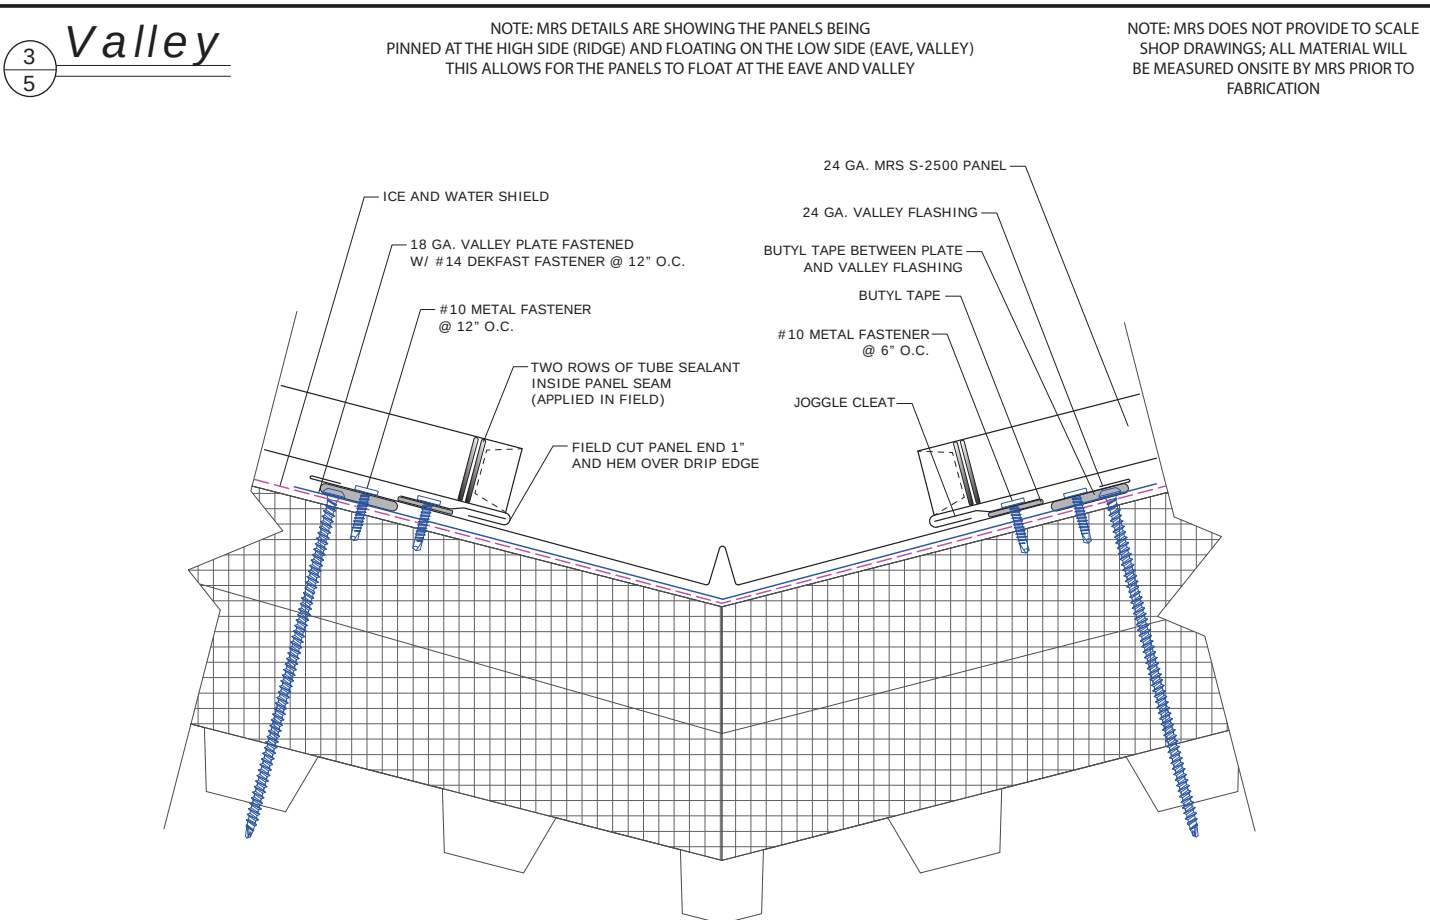
**3** Valley

NOTE: MRS DETAILS ARE SHOWING THE PANELS BEING PINNED AT THE HIGH SIDE (RIDGE) AND FLOATING ON THE LOW SIDE (EAVE, VALLEY) THIS ALLOWS FOR THE PANELS TO FLOAT AT THE EAVE AND VALLEY

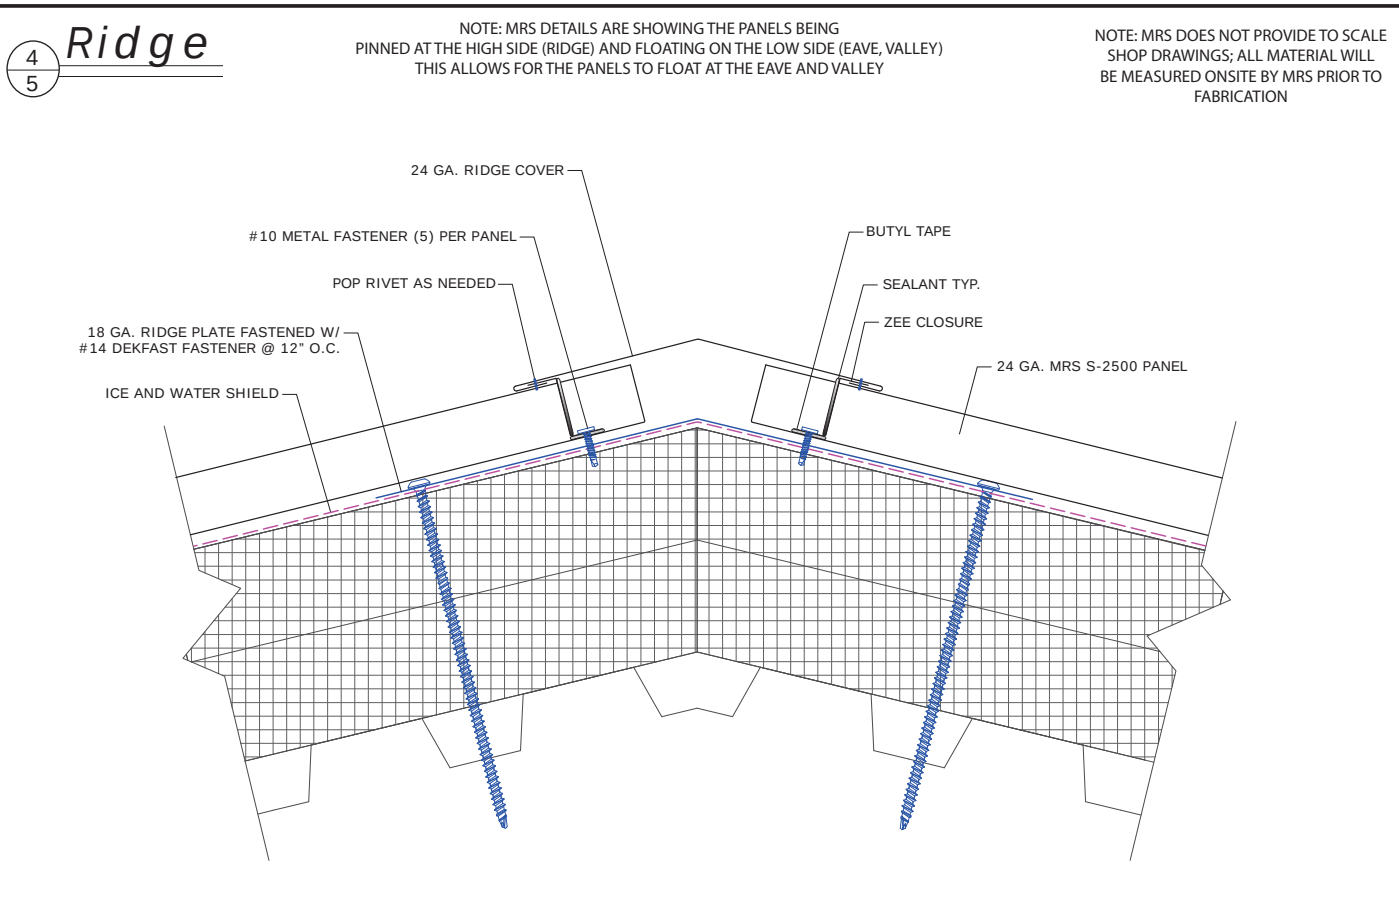
**4** Ridge

NOTE: MRS DETAILS ARE SHOWING THE PANELS BEING PINNED AT THE HIGH SIDE (RIDGE) AND FLOATING ON THE LOW SIDE (EAVE, VALLEY) THIS ALLOWS FOR THE PANELS TO FLOAT AT THE EAVE AND VALLEY
